INDOOR AIR QUALITY REASSESSMENT

**Attleboro District Court
88 North Main Street
Attleboro, Massachusetts**

Prepared by:
Massachusetts Department of Public Health
Bureau of Environmental Health
Indoor Air Quality Program
March 2017

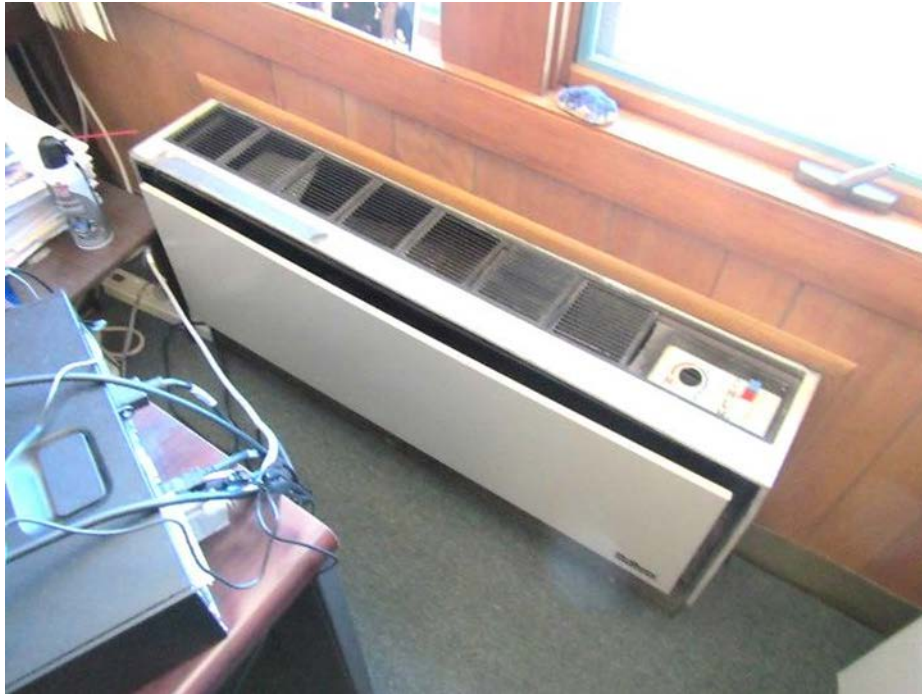
Picture 1

Mechanical ventilation in most areas is provided by unit ventilators (univents) that draw air from the exterior via a fresh air intake (Pictures 1 and 2). The univents examined were equipped with metal/mesh filters that provide minimal filtration (Picture 3). Univents in the courtroom had a filter medium that needs to be physically cut to size (Picture 4). MDPH recommends filters of a Minimum Efficiency Reporting Value (MERV) of 8, which are adequate in filtering out pollen and mold spores (ASHRAE, 2012). As observed from the outside, it appeared that the univents had no louvers or intake controls to adjust the amount of airflow into the units (Picture 5). In addition, none of the areas were equipped with exhaust ventilation. Lack of air exchange/circulation can lead to the build-up of naturally occurring pollutants in the space, which can result in IAQ/comfort complaints.

It is also important to note that the univents are over 30 years old. Efficient function of equipment of this age is difficult to maintain, since compatible replacement parts are often unavailable. According to the American Society of Heating, Refrigeration and Air-Conditioning Engineering (ASHRAE), the service life¹ for a unit heater, hot water or steam is 20 years, assuming routine maintenance of the equipment (ASHRAE, 1991). Despite attempts to maintain the equipment, the optimal operational lifespan of this equipment has been exceeded.

Univent in Probation Department, 30 or more years old

1. Operate mechanical ventilation continuously in all areas during occupied periods.
2. Have an HVAC engineering firm evaluate univents for proper operation and future replacement, including the addition of exhaust vents in rooms containing univents.
3. Clean univents and change filters 2 to 4 times a year. Determine if univents can be outfitted with more efficient filters, MERV 8 or higher.
4. Ensure univents, supply vents and personal fans are cleaned periodically to prevent buildup and re-circulation of dust and debris.
5. Replace water-damaged ceiling tiles once source of leak is repaired.
6. Keep plants in good condition, avoid overwatering, and remove from the airstream of heating and ventilation equipment.
7. Remove carpeting in basement restroom.

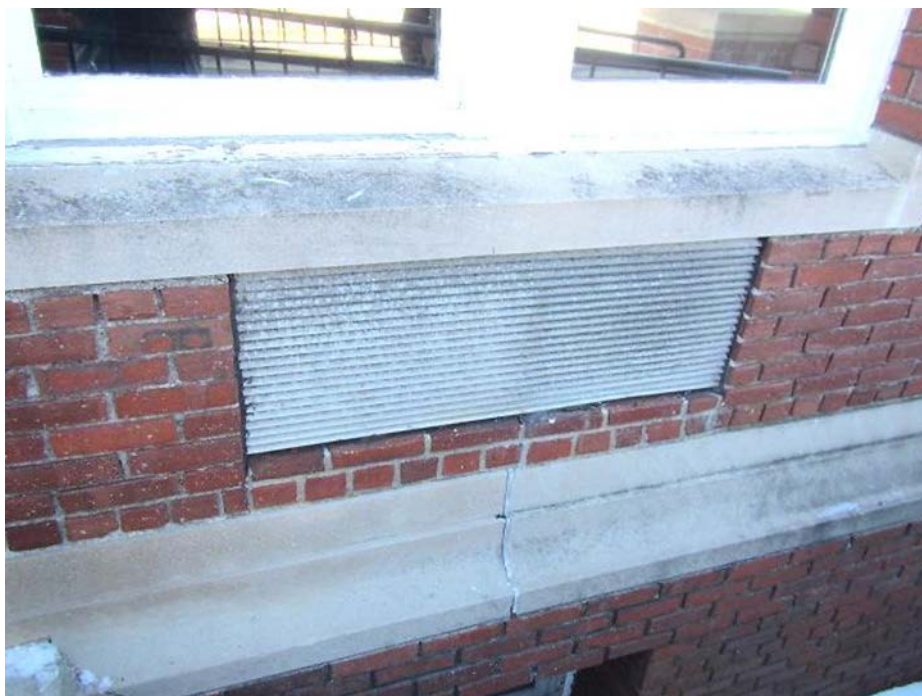
Picture 2

Outside air intake for univents

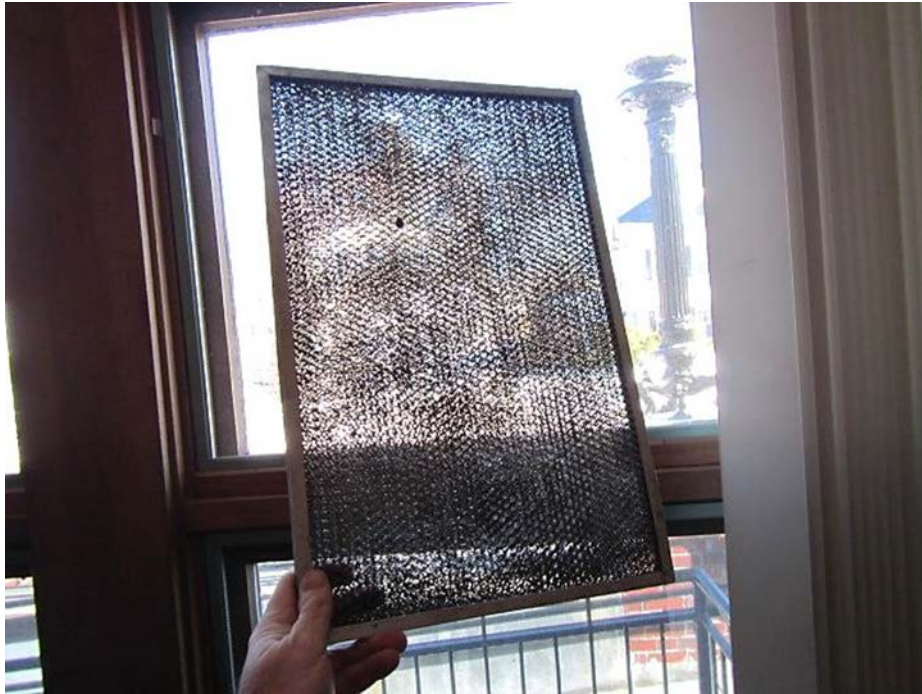
Picture 3

Metal-mesh filter for univent

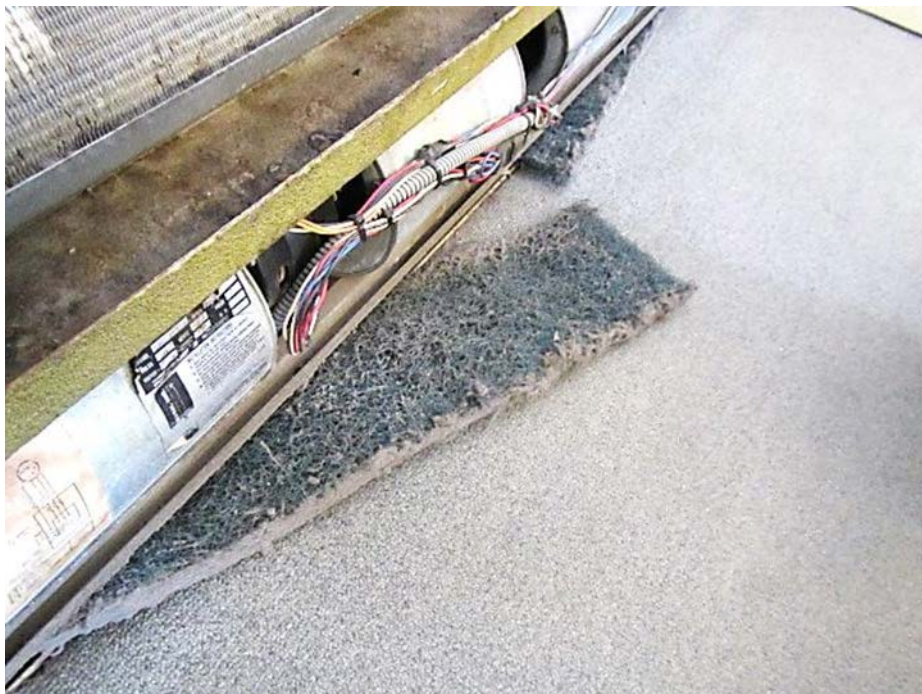
Picture 4

Loose filter media in Courtroom univent

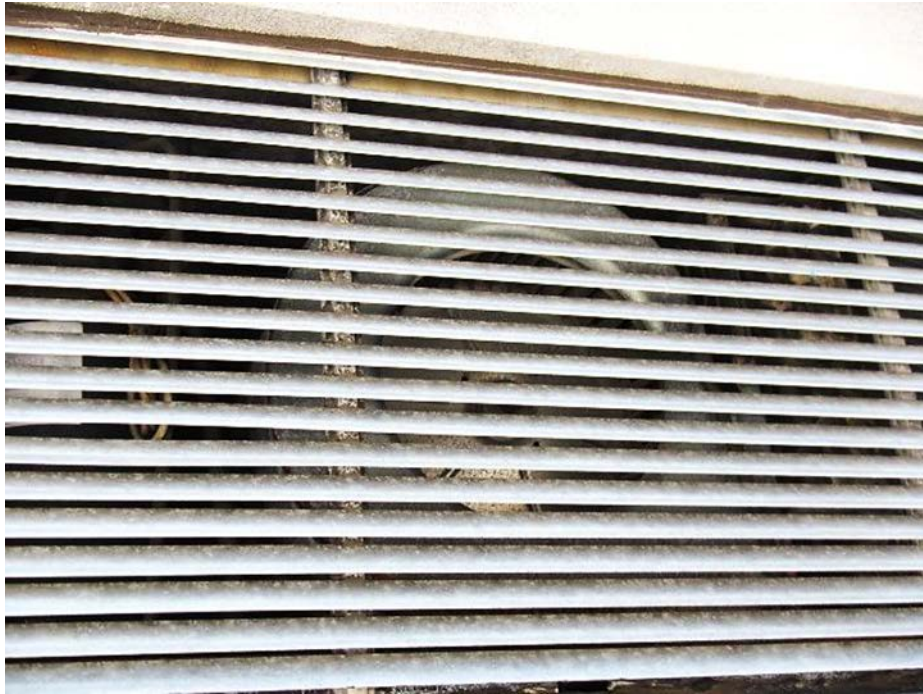
Picture 5

Univent air intake, note no mechanism/movable louvers for adjusting air intake

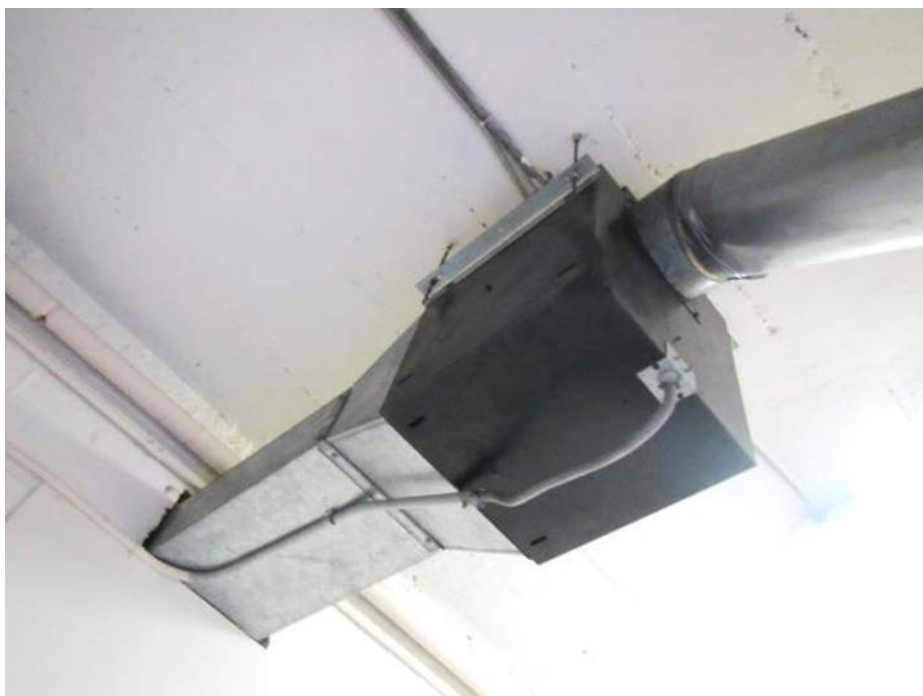
Picture 6

Basement areas are mechanically ventilated by an air handling unit (AHU, Picture 6), controlled by a wall-mounted thermostat. Supply and return air is provided by ducted vents (Picture 7).

Basement air handling unit

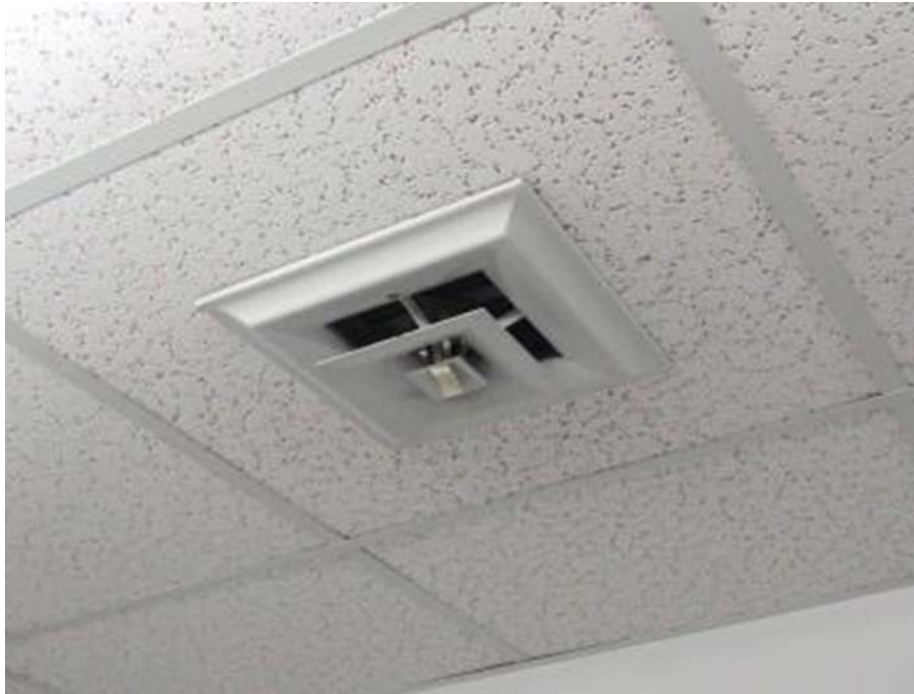
Picture 7

Basement supply vent

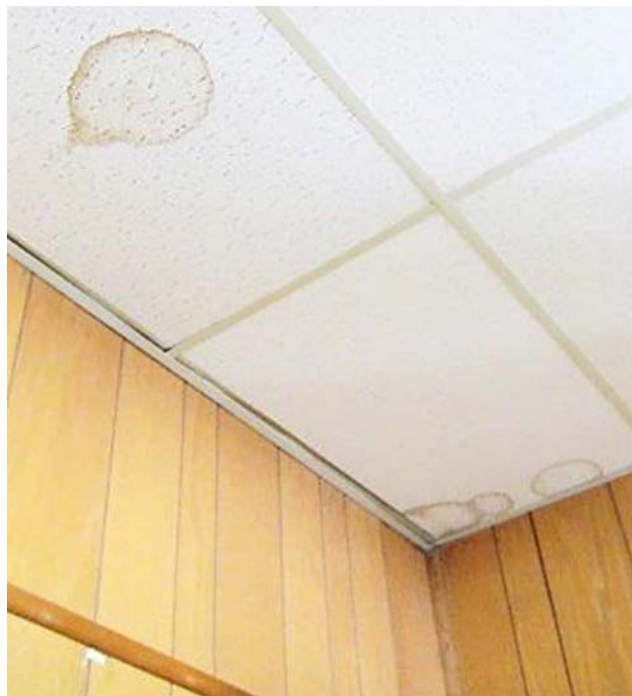
Picture 8

Stained ceiling tiles were observed in several areas, including the Probation Department (Picture 8, Table 1). Water-damaged ceiling tiles can indicate roof or plumbing leaks. Any leaks should be reported promptly to building maintenance staff to ensure they can be repaired and materials can be dried. The United States Environmental Protection Agency (US EPA) and the American Conference of Governmental Industrial Hygienists (ACGIH) recommend that porous materials be dried with fans and heating within 24 to 48 hours of becoming wet (US EPA, 2008; ACGIH, 1989). If porous materials are not dried within this time frame, mold growth may occur. Once mold has colonized porous materials, they are difficult to clean and should be removed and discarded.

Water-damaged ceiling tiles in the Probation Department

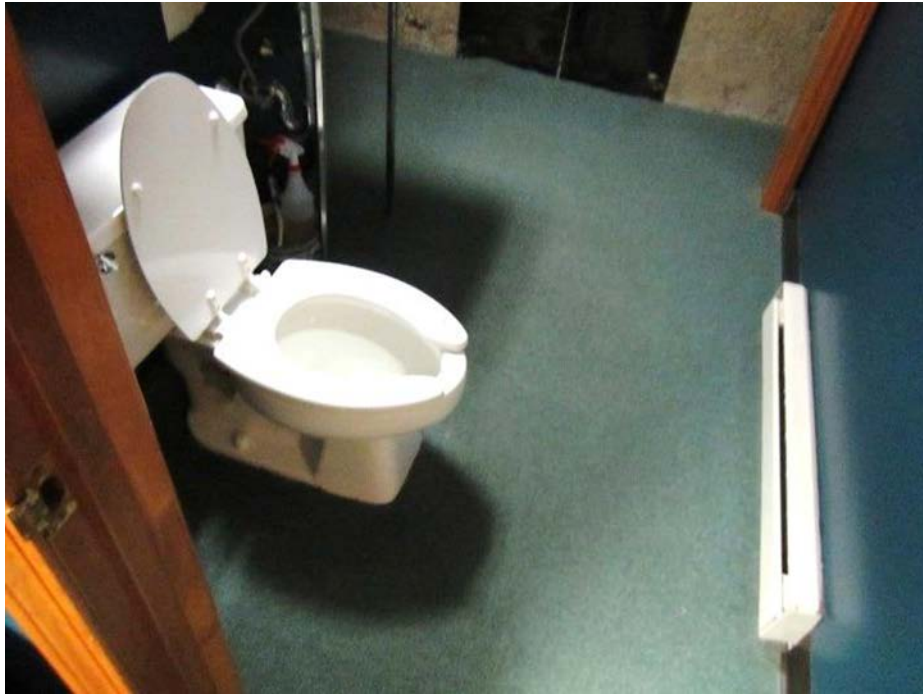
Picture 9

The bathroom in the basement had wall-to-wall carpeting (Picture 9). Carpeting in restrooms is not recommended because it can become easily moistened or contaminated, which would necessitate its removal.

Carpeting in basement bathroom

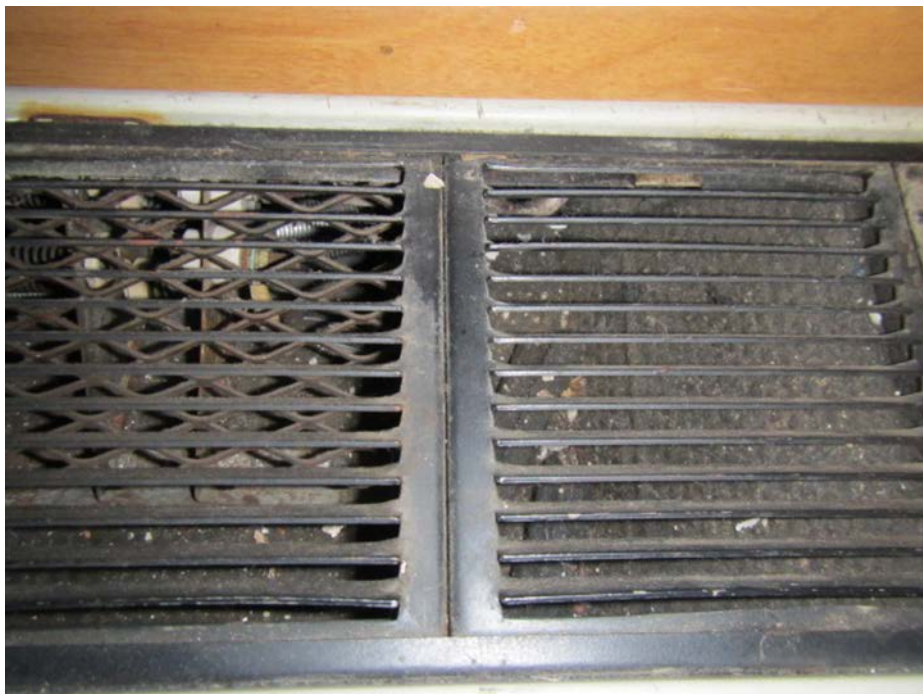
Picture 10

Several univents, portable and stand-up fans were observed to have accumulated dust/debris (Picture 10). Operation of this equipment can re-aerosolize accumulated dust particles.

Dust/debris inside univent grill

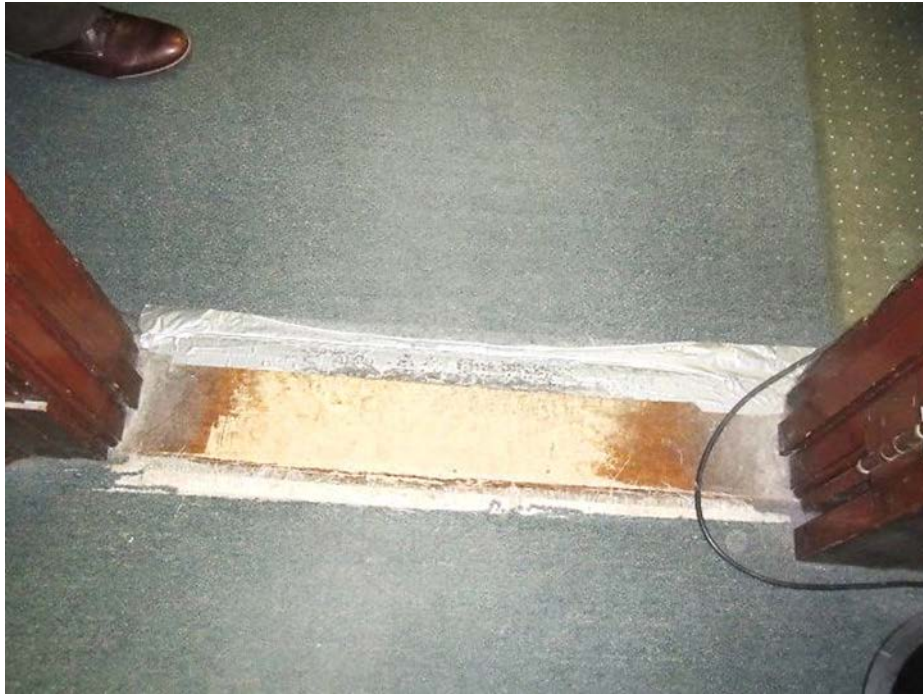
Picture 11

Many areas contained old, worn carpeting that appeared to be past its useful life (Picture 11). The Institute of Inspection, Cleaning, and Restoration Certification (IICRC), recommends that carpeting be cleaned annually, or semi-annually in high-traffic areas (IICRC, 2012). Since the average lifespan of carpeting is approximately eleven years (Bishop, 2002), consideration should be given to planning the installation of new flooring. In general, carpeting is not recommended in basement areas, especially if exposed to chronic moisture.

Old/worn carpeting held by duct tape

8. Replace old/stained/worn carpeting throughout the building; consider non-porous flooring such as tile for below-grade areas.
9. Clean existing carpeting annually (or semi-annually in soiled high traffic areas) as per the recommendations of the Institute of Inspection, Cleaning and Restoration Certification (IICRC).

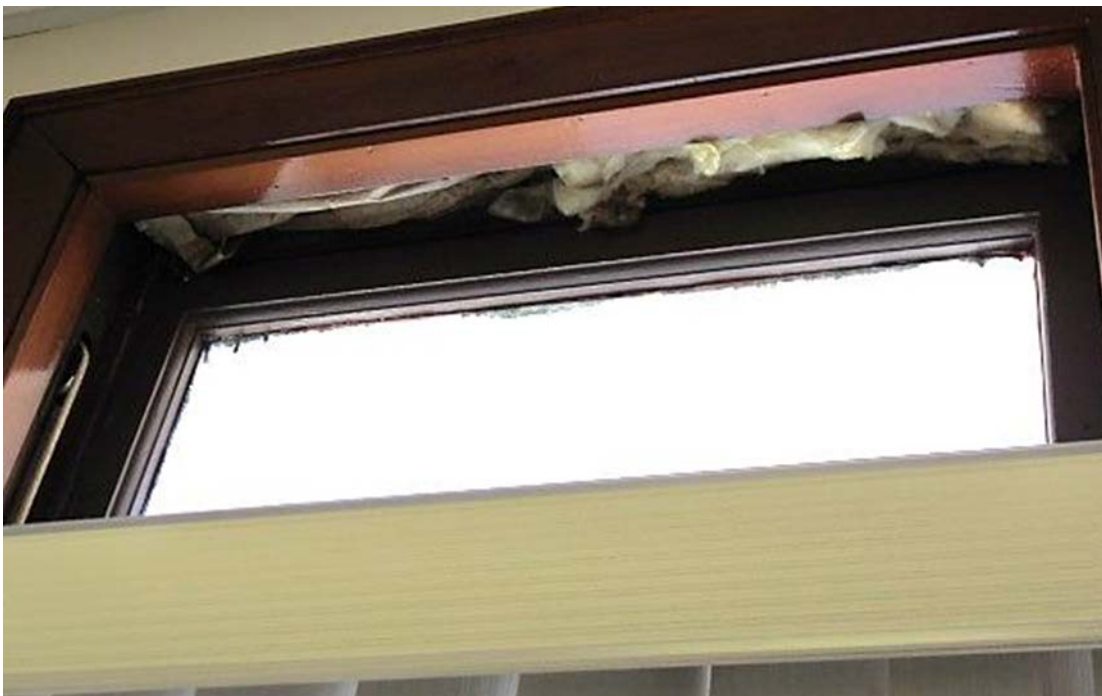
Picture 12

Exposed fiberglass insulation material was observed around windows on the second floor (Picture 12). Fiberglass can be irritating to the skin, eyes and respiratory system.

Exposed fiberglass insulation around windows on the 2nd floor

12. Remove or cover exposed fiberglass insulation around windows on the second floor.
13. Refer to resource manual and other related IAQ documents located on the MDPH's website for further building-wide evaluations and advice on maintaining public buildings. These documents are available at: <http://mass.gov/dph/iaq>.

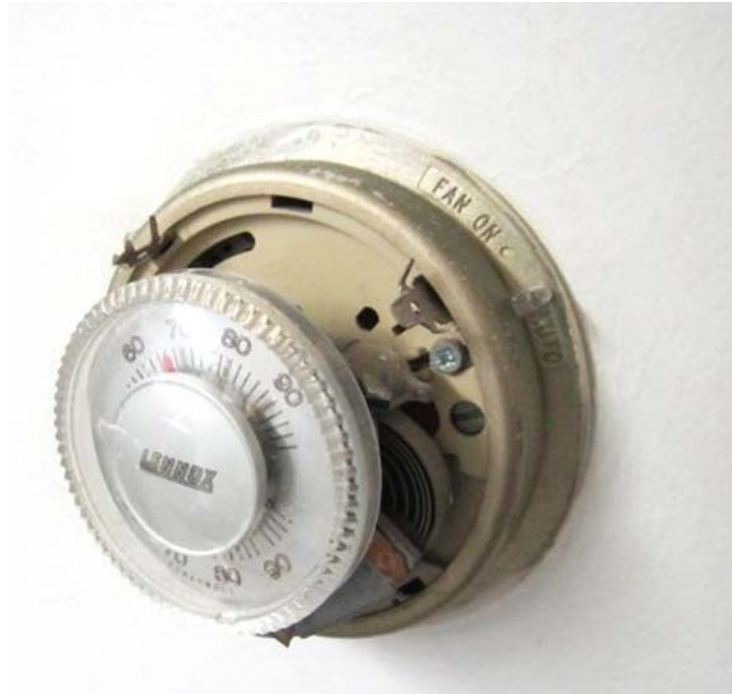
Picture 13

Finally, mercury-containing thermostats were observed in the Juvenile Probation area of the basement (Picture 13). The mercury in these thermostats is in an airtight glass ampoule. While the mercury is not evaporating into the environment when intact, these glass ampoules pose a hazard by accidental breakage. If broken, mercury could be released into the indoor environment resulting in building evacuation, exposure of occupants to mercury vapor, and a costly hazardous material clean up/remediation.

Mercury-containing thermostat in Juvenile Probation area

10. Consider replacing mercury-containing thermostats with digital/programmable thermostats to improve temperature control. Have the mercury-containing items removed for proper disposal.
